# *Property Inspection Report*

*533 Meek Avenue, Hayward*

**421130H**

**Inspection Date:** September 08, 2014

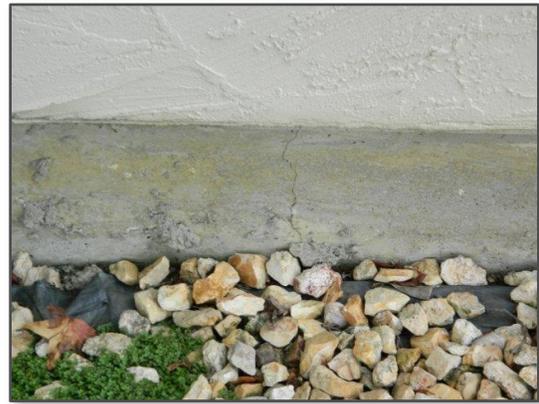
1. **MONITOR:** Minor vertical cracks were observed in the foundation. This type and pattern of cracking is usually the result of concrete shrinkage as it cures. Shrinkage cracks are very common and are not normally a concern. We recommend a periodic inspection.

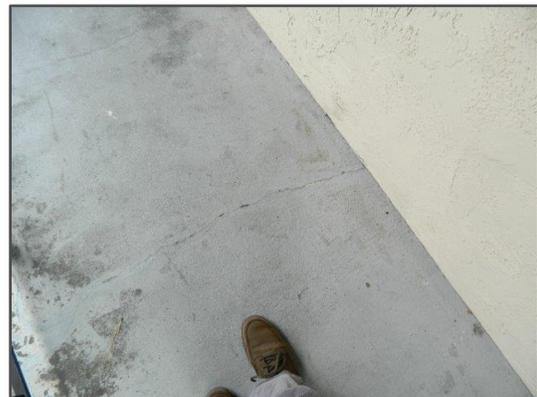
2. **REPAIR:** The walkway has cracks that should be sealed. By sealing the cracks moisture will not keep seeping under these areas and cause the cracks to widen. If the cracks are not sealed, it will hasten the damage of the walkway.

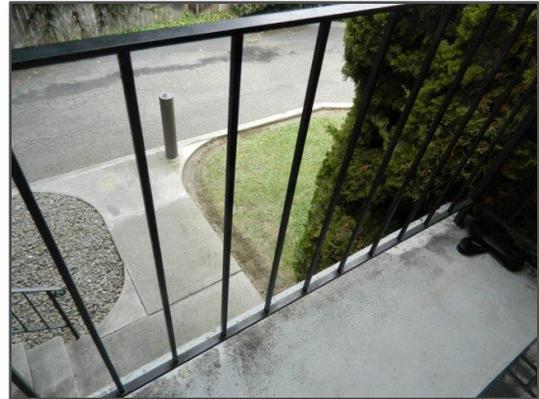
3. **SAFETY ISSUE:** The baluster spacing at the perimeter of the stairs and landing is too wide. It's possible for a small child to slip through the railing and fall. Current codes specify that baluster spacing can be no more than 4 inches wide. Even though this requirement may not have existed at the time this property was built, or the local municipality may never have adopted it, I consider this to be a life/safety issue, and feel it would be prudent to bring the baluster spacing up to current code. A competent carpenter that specializes in decks should be consulted to discuss options and cost.

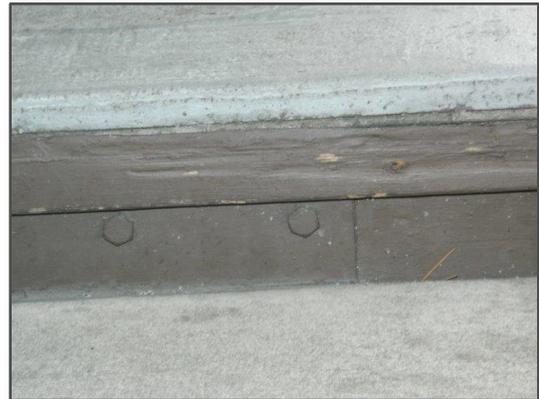
4. **REPAIR:** The stair tie-in where the staircase meets the entry fascia is damaged. There is also possible interior damage. We recommend disconnecting the stairs from the deck fascia make repairs and re-connect the staircase.

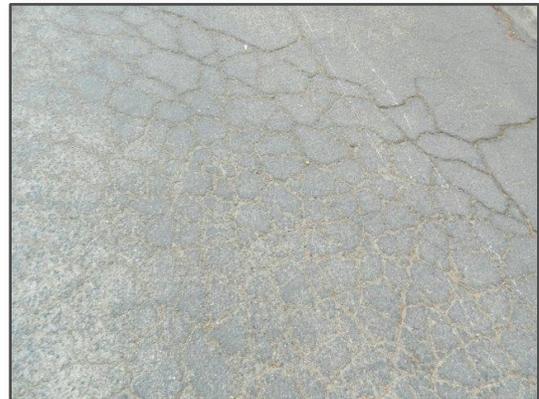
5. **IMPROVE:** The concrete driveway has some cracks that detract from its appearance, but it is still very viable and can probably be satisfactorily repaired. I recommend the client consult a reputable mason to discuss repair options and cost.

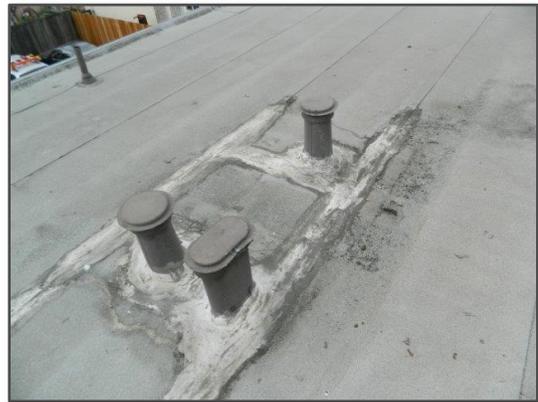
1. **MONITOR:** Work has been done in the past at the roof coverings. It appears at this time the roof has no leaks. We cannot guarantee the roof for water tightness. We recommend contacting a licensed roofer for a water tightness report.

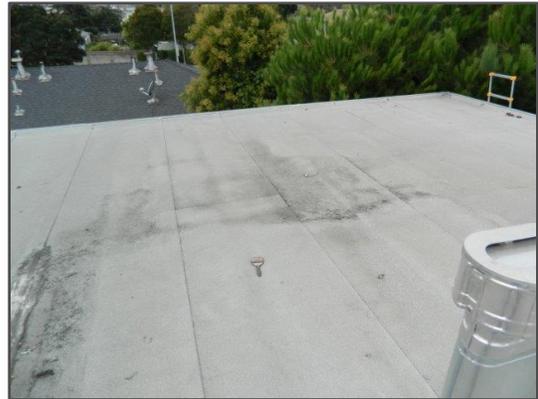
2. **DEFERRED COST:** The roof is ponding. Roof ponding is the retention of water on a low-slope or flat roof caused by a deflection of the roof's underlying structural components. Ponding water on a roof causes leaks, algae and fungi growth. If left unattended, roof ponds can lead to the collapse of a roof. The size of roof ponds increases over time because the weight of the water causes additional deflection of the structural membranes underneath. Eventually, the structure will not be able to carry the increased load and the roof collapses. Contact a licensed roofer for repairs and costs.

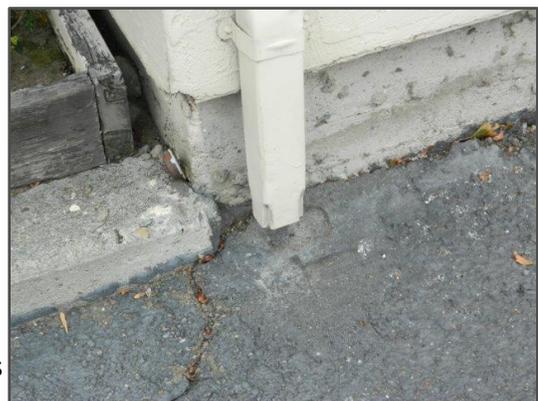
3. **REPAIR:** The bottom of the downspout that diverts the water is missing. We recommend installing the missing diverters.

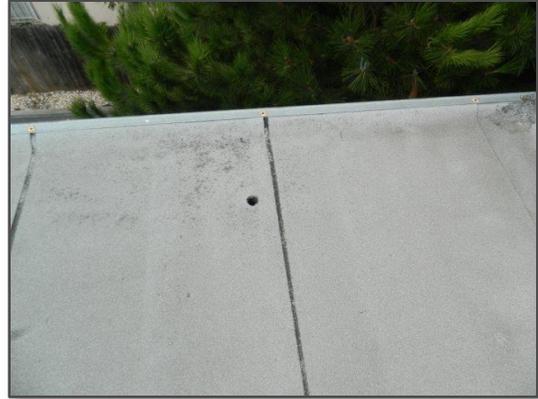
4. **REPAIR:** The drains on the flat roof should have a protective grate to allow the water to drain but keeps the debris from entering the downspouts. The drains on this roof do not have the proper grate. We recommend having them installed.

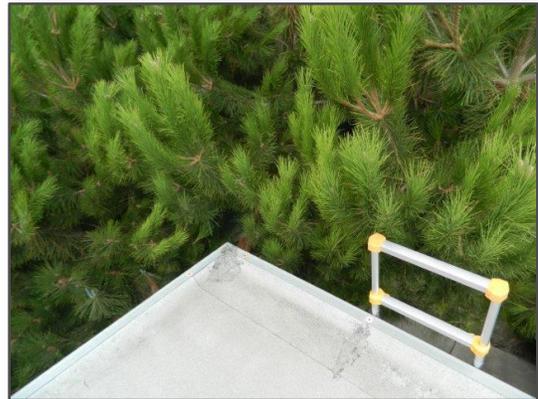
5. **IMPROVE:** Trees or branches overhang the house. This condition, if allowed to continue, could result in damage to either the roof covering or the siding on the home. Recommendation: Trim branches to provide at least a six-inch separation between roof or wall and tree branches.

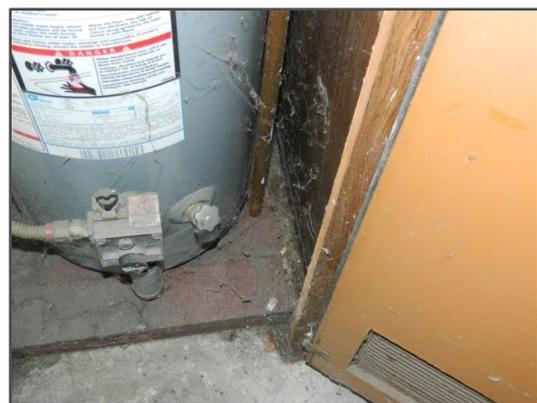
1. **REPAIR:** The TPR valve does not discharge to the exterior in the laundry room. Contract a licensed contractor to have TPR valve terminated to the outside.

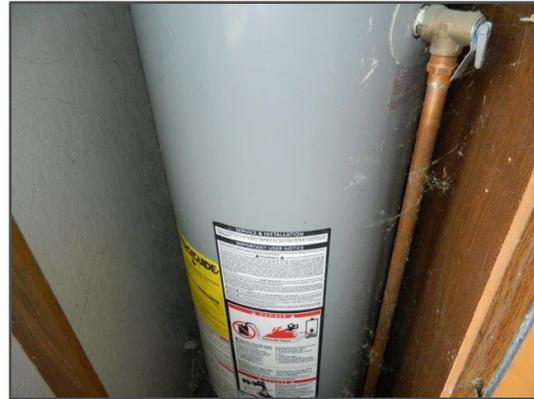
2. **REPAIR:** The water heaters in units 1,2,3,4 and the laundry room are not strapped correctly and/or are strapped with improper materials. A water heater should be anchored with 24 gauge metal bands/tape or 1/2 inch diameter metal conduit that wrap all the way around/loop the body. This type of anchoring will secure it during earthquakes, a water heaters that is not correctly secured and anchored to adjacent walls or floors it can move or tip over. This movement has resulted in gas line or water line leaks, and electrical wiring damage. Gas line leaks and damaged electrical wiring pose health and fire hazards, and water line leaks can cause significant and costly property damage. Contact a licensed contractor for repairs. Please note, the plumbing code, as it relates to water heater strapping, has been superseded by higher standards set forth by the California Health and Safety Code. The state architect's specifications, published in 1992, stand as the legal criteria for adequate strapping of water heaters in California. The actual plumbing code reference is as follows:

CPC 508.2 says "In seismic zones C, D, E and F, water heaters shall be anchored or strapped to resist horizontal displacement due to earthquake motion. Strapping shall be at points within the upper one-third (1/3) and lower one-third (1/3) of its vertical dimensions. At the lower point, a minimum distance of four (4) inches (102 mm) shall be maintained above the controls with the strapping.

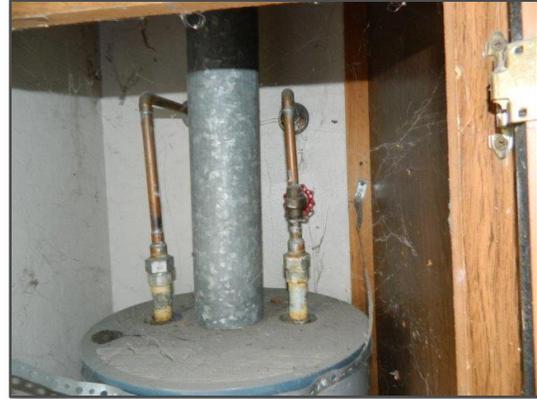
6. **IMPROVE:** The water heater in the laundry room is installed without the appropriate flex line. In earthquake areas this helps to fight against leaks during an earthquake. Contact a licensed plumber for repairs.

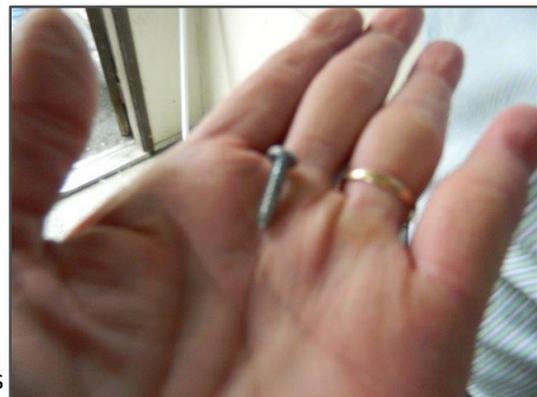
1. **REPAIR:** Wrong type of twist outs was used in the sub panel in the laundry room. The screws used for a panel are blunted at the end to ensure that they do not pierce any wires in the panels. Most twist outs can be obtained at a local hardware store. We recommend installing the correct type of twist outs.

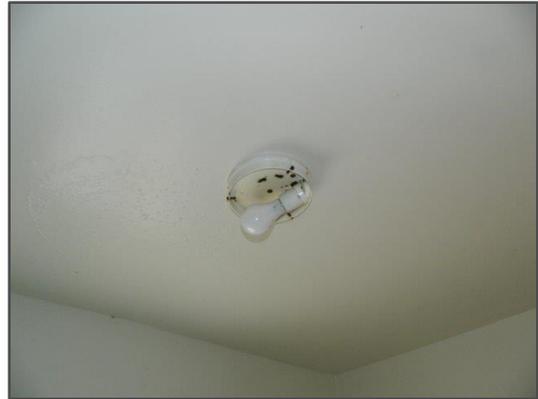
2. **REPAIR:** There are light fixtures missing with the wiring exposed in units 1 and 3. We recommend installing a new fixture.

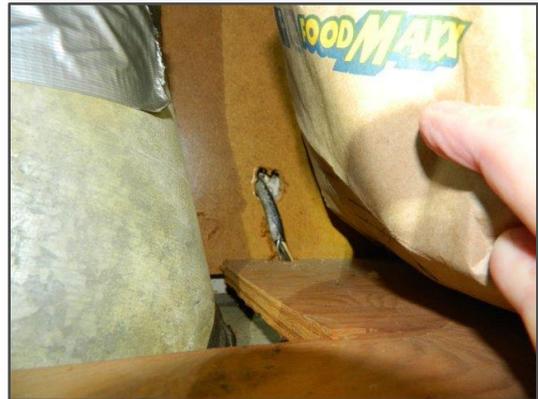
3. **REPAIR:** There is uncontained wiring above the kitchen exhaust fan in the cabinet in units 1 and 3. We recommend either installing flexible conduit or close off the cabinet.

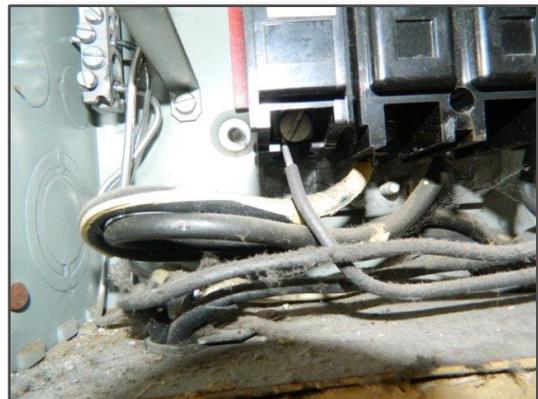
7. **SAFETY ISSUE:** Aluminum solid-conductor branch circuit wiring is a potential fire hazard. The US Consumer Product Safety Commission (US CPSC) recommends that solid-conductor aluminum wiring either be replaced with solid-copper conductor wiring throughout the building or every aluminum-wire connection be "pigtailed to copper wires" using special connectors (AMP Corporation's COPALUM connectors) to ensure safe operation of these circuits. Because of the properties of aluminum (corrosion and arcing), aluminum wire connections can overheat sufficiently to ignite a fire without ever drawing enough current to trip a circuit breaker or blow a fuse. Upon proper installation using UP CPSC-approved connectors the safety of the system will be improved to acceptable levels. Be especially wary of work by untrained electricians and equally wary of alternative repair products as there is ample field evidence and formal studies confirming that other products (such as CO/ALR receptacles or recently-marked special purple twist-on wire connectors) do not perform reliable in the field. An improper repair can actually increase risk. See the Internet website <http://www.inspect-ny.com/aluminum.htm> for detailed information including the CPSC recommendations.

7. **SAFETY ISSUE:** Aluminum solid-conductor branch circuit wiring is a potential fire hazard. The US Consumer Product Safety Commission (US CPSC) recommends that solid-conductor aluminum wiring either be replaced with solid-copper conductor wiring throughout the building or every aluminum-wire connection be "pigtailed to copper wires" using special connectors (AMP Corporation's COPALUM connectors) to ensure safe operation of these circuits. Because of the properties of aluminum (corrosion and arcing), aluminum wire connections can overheat sufficiently to ignite a fire without ever drawing enough current to trip a circuit breaker or blow a fuse. Upon proper installation using UP CPSC-approved connectors the safety of the system will be improved to acceptable levels. Be especially wary of work by untrained

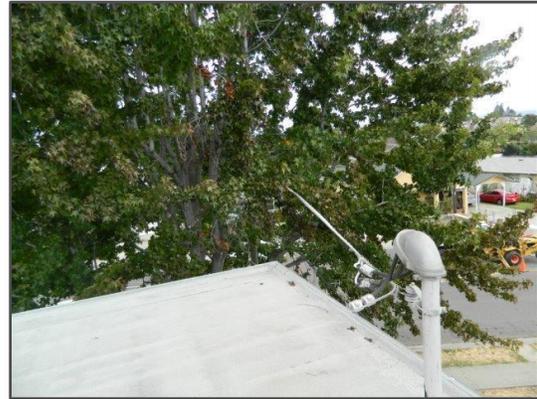
8. **IMPROVE:** The overhead service conductors from the utility pole pass through, and are in contact with, the branches of one or more trees before they reach the weather head. These conductors are vulnerable to damage caused when the trees place too great a strain on the conductors, attachment and weather head mast, damage the insulation or break the connection to the house. Since trimming trees around these conductors is extremely dangerous, I recommend having these trees professionally pruned. This is typically the responsibility of the homeowner, unless the utility provider has an easement.

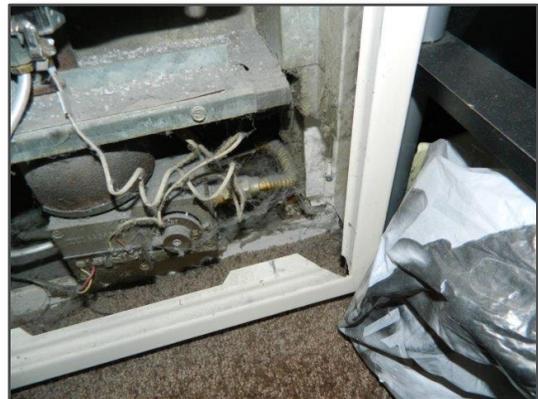
1. **SAFETY ISSUE:** The furnace of units 1 and 2 has a brass gas line connector. These older brass connectors have a serious flaw in how their tubing was joined to their end pieces. Over time, the end pieces can separate from the tubing, and cause a serious gas leak, explosion, or fire. To our knowledge, these dangerous uncoated brass connectors have not been made for more than 20 years, but many of them are still in use. The older these connectors get, the greater the possibility of failure.

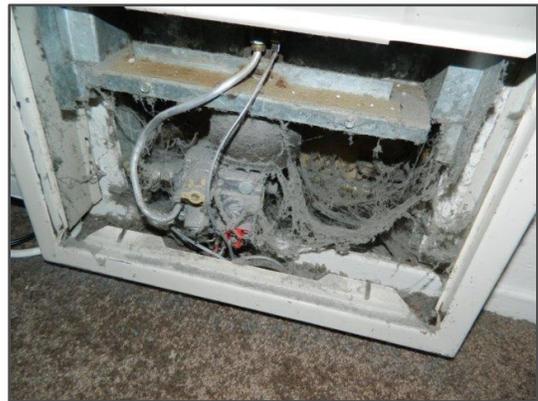
2. **IMPROVE:** The furnaces of units 1 and 2 are very dirty and needs cleaning. We recommend the client(s) have this system cleaned now by a reputable/professional duct-cleaning company, and once every year thereafter.

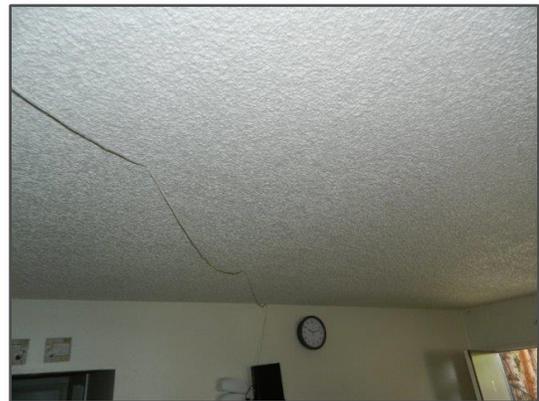
1. **DEFERRED COST:** This building has acoustic ceilings. Before 1978 Acoustic ceilings were most likely asbestos. Asbestos was banned in the USA in 1978. The gov't did allow for all asbestos texture supplies to be used up. There are kits available to test the acoustic. You can also have it tested.

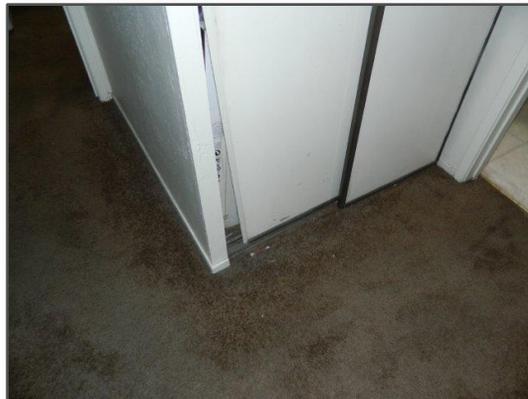
2. **REPAIR:** The closet doors of units 1 and 2 are off track. We recommend having it adjusted.

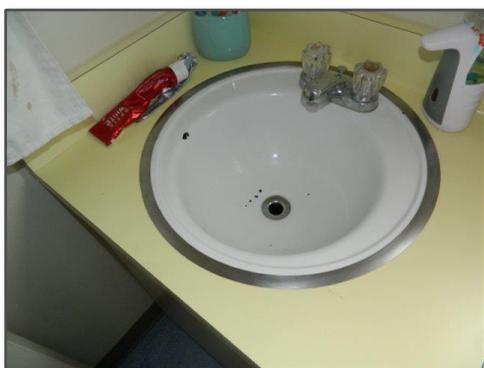
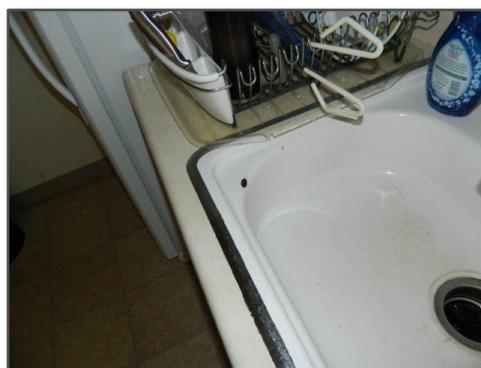
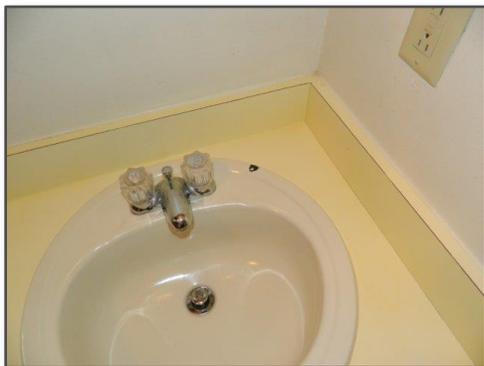
3. **REPAIR:** The bathroom sink of units 1 and 2 and kitchen sink in units 2 are chipped and/or has cosmetic damage. Chip kits are available at the Home Depot or most hardware stores.

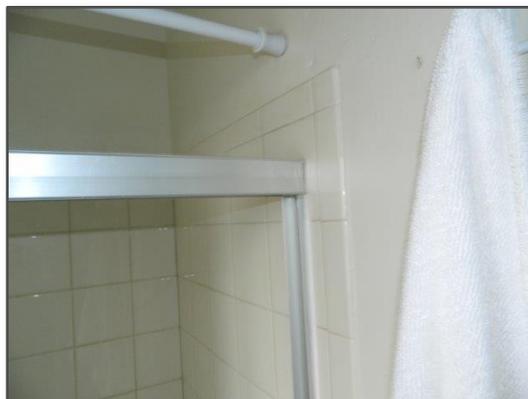
5. **SAFETY ISSUE:** The shower door top rail in the bathroom is not connected by a safety screw to the side rails. The safety screw holds the top rail to the side rails so the doors and top rail do not come off the side rail causing injuries. We recommend installing a safety screw.
