WOOD DESTROYING PESTS AND ORGANISMS INSPECTION REPORT

Building No. 2828	Street JOSEPH AVENUE	City SAN JOSE	Zip 95124	Date of Inspection 09/28/16	Page 1 of 8
-----------------------------	--------------------------------	-------------------------	---------------------	---------------------------------------	-----------------------

General Description: Two story four-plex.	Inspection Tag Posted: Subarea.
	Other Tags Posted: None found.

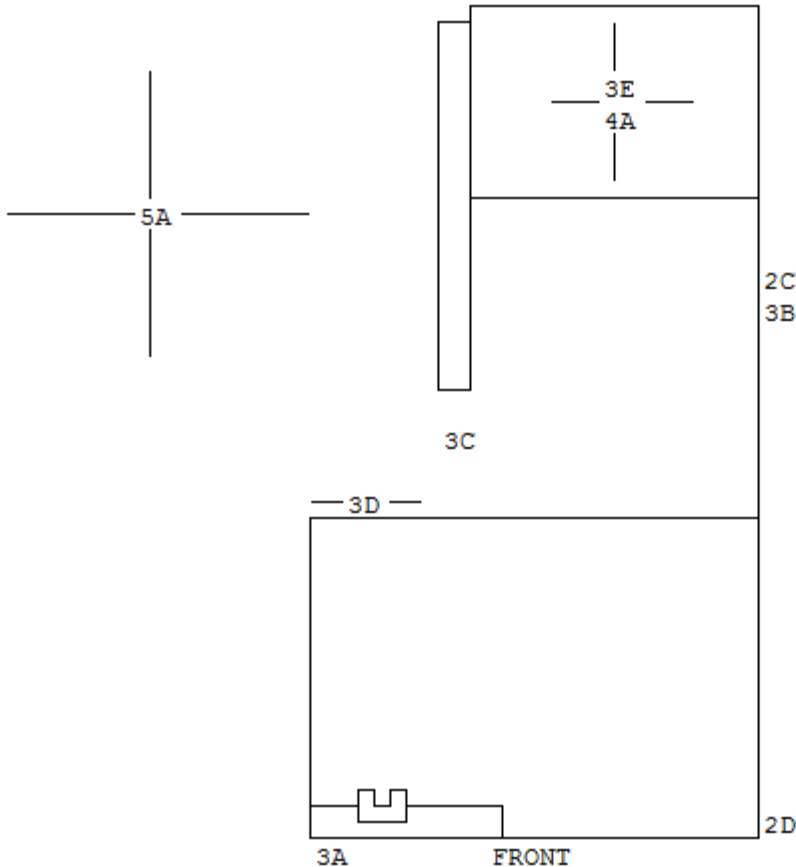
2A. FINDING: Evidence of drywood termites noted as 2A on the diagram. Location: Laundry room, utility boxes and exterior.

2B. FINDING: Drywood termite damage to the utility boxes.

2C. FINDING: Drywood termite damage to the laundry room door jambs, noted as 2C on the diagram.

2D. FINDING: Drywood termite damage to the eaves at unit 1, noted as 2D on the diagram.
RECOMMENDATION: Remove the damage and replace or structurally reinforce. If possible we will chisel or cut out the damaged area and fill with either plastic or wood filler.

2E. FINDING: Drywood termite damage to the second story rafter tails at unit 4.
RECOMMENDATION: Remove the damage and replace or structurally reinforce. If possible we will chisel or cut out the damaged area and fill with either plastic or wood filler.

3A. FINDING: FUNGUS DAMAGE, noted as 3A on the diagram, was found to the rafter tails.
RECOMMENDATION: REMOVE and REPLACE the damaged wood members. If possible we will chisel or cut out the damaged area and fill with either a plastic or wood filler. We will then sand and primer paint.
NOTE: We will repair roof in the area we work on only. To insure roof for water tightness a roofing contractor or roof inspector would have to give roof certifications. This company does not certify roofs.

3D. FINDING: FUNGUS DAMAGE, noted as 3D on the diagram, was found to the eave boards.
RECOMMENDATION: REMOVE and REPLACE the damaged wood members. If possible, we will chisel or cut out the damaged area and fill with either a plastic or wood filler. We will then sand and primer paint.
NOTE: We will repair roof in the area we work on only. To insure roof for water tightness a roofing contractor or roof inspector would have to give roof certifications. This company does not certify roofs.

RECOMMENDATION: It is NOT FEASIBLE to FUMIGATE this property, as it is a MULTI-UNIT COMPLEX. Therefore, we are submitting the following below standard measure. LOCALLY TREAT for drywood termites with a registered termiticide. Remove and/or mask all accessible pellets. NOTE: Local treatment is not intended to be an entire structure treatment method. If infestations of wood-destroying pests extend or exist beyond the area(s) of local treatment, they may not be exterminated.

RECOMMENDATION: Remove the damage and replace or structurally reinforce. If possible we will chisel or cut out the damaged area and fill with either plastic or wood filler.
