# WOOD DESTROYING PESTS AND ORGANISMS INSPECTION REPORT

Building No. <b>660</b>	Street <b>SCOFIELD AVENUE</b>	City <b>EAST PALO ALTO 94303</b>	Zip <b>94303</b>	Date of Inspection <b>02/18/22</b>	Page <b>1 of 9</b>

<b>Report # 433135 T</b>
Ordered by: <b>ARA NEWMARK</b> <b>SCOTT KILPATRICK</b> <b>431 FLORENCE ST</b> <b>PALO ALTO, CA 94301</b>		Property Owner and/or Party of Interest: <b>NOT DISCLOSED</b>		Report sent to:		
COMPLETE REPORT <input checked="" type="checkbox"/> LIMITED REPORT <input type="checkbox"/> SUPPLEMENTAL REPORT <input type="checkbox"/> REINSPECTION REPORT <input type="checkbox"/>						
General Description: <b>Two story complex.</b>				Inspection Tag Posted: <b>Laundry room.</b>		
				Other Tags Posted: <b>None found.</b>		
An inspection has been made of the structure(s) shown on the diagram in accordance with the Structural Pest Control Act. Detached porches, detached steps, detached decks and any other structures not on the diagram were not inspected. Diagram is not to scale. Locations are only approximate.

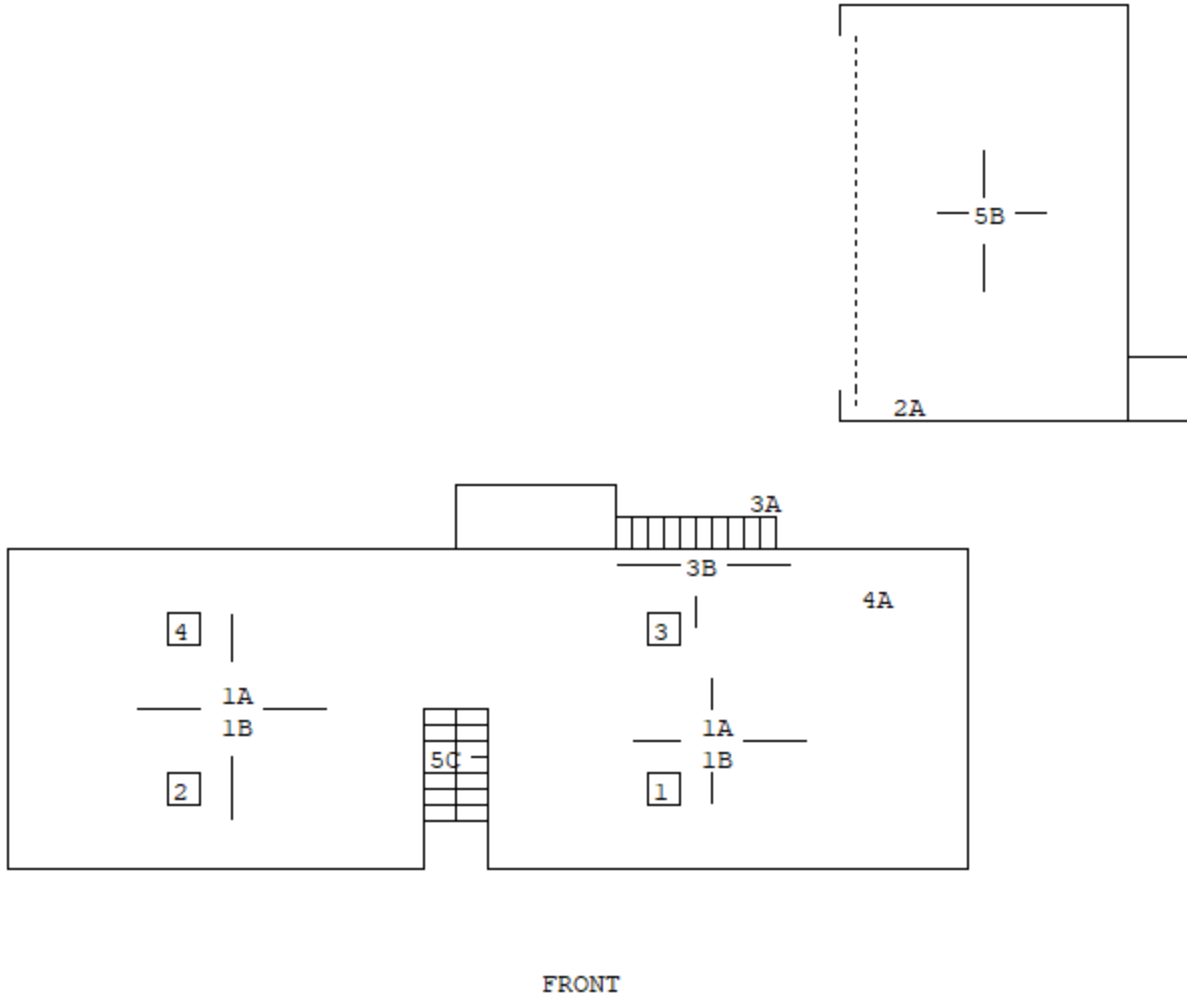
DIAGRAM NOT TO SCALE, LOCATIONS ONLY APPROXIMATE

The findings on this report, as listed below, are also noted on the diagram as numbers and letters, i.e. 1A, 1B, 3A, etc. Locations of these items are only approximate as it is impossible to be exact. We recommend that interested party(ies) closely exam the body of this report for detailed information regarding each item. We list locations on diagrams for approximate information regarding our findings and recommendations.

1A. FINDING: Evidence of subterranean termites found in the subarea and noted as 1A on the diagram.  
RECOMMENDATION: CHEMICALLY TREAT with a registered termiticide adjacent to FOUNDATION WALLS, PIERS and vertical pipes to control subterranean termites.

1B. FINDING: Evidence in the form of SHELTER TUBES for subterranean termites were found and noted as 1B on the diagram.  
RECOMMENDATION: AFTER treatment to control subterranean termites is completed, remove all shelter tubes in these areas.

2B. FINDING: Evidence of drywood termites, in the form of drywood PELLETS, were found at the areas noted as 2B on the diagram.

3A. FINDING: Fungus damage at the railing noted as 3A on the diagram.

5C. FINDING:                      No access to subarea UNDER the STAIRWAY, 5C on the diagram.
